CLOSET WALL PROJECT (LDRC)

Progress Report No. 2

Testing Program

LDRC CLOSET WALL PROJECT

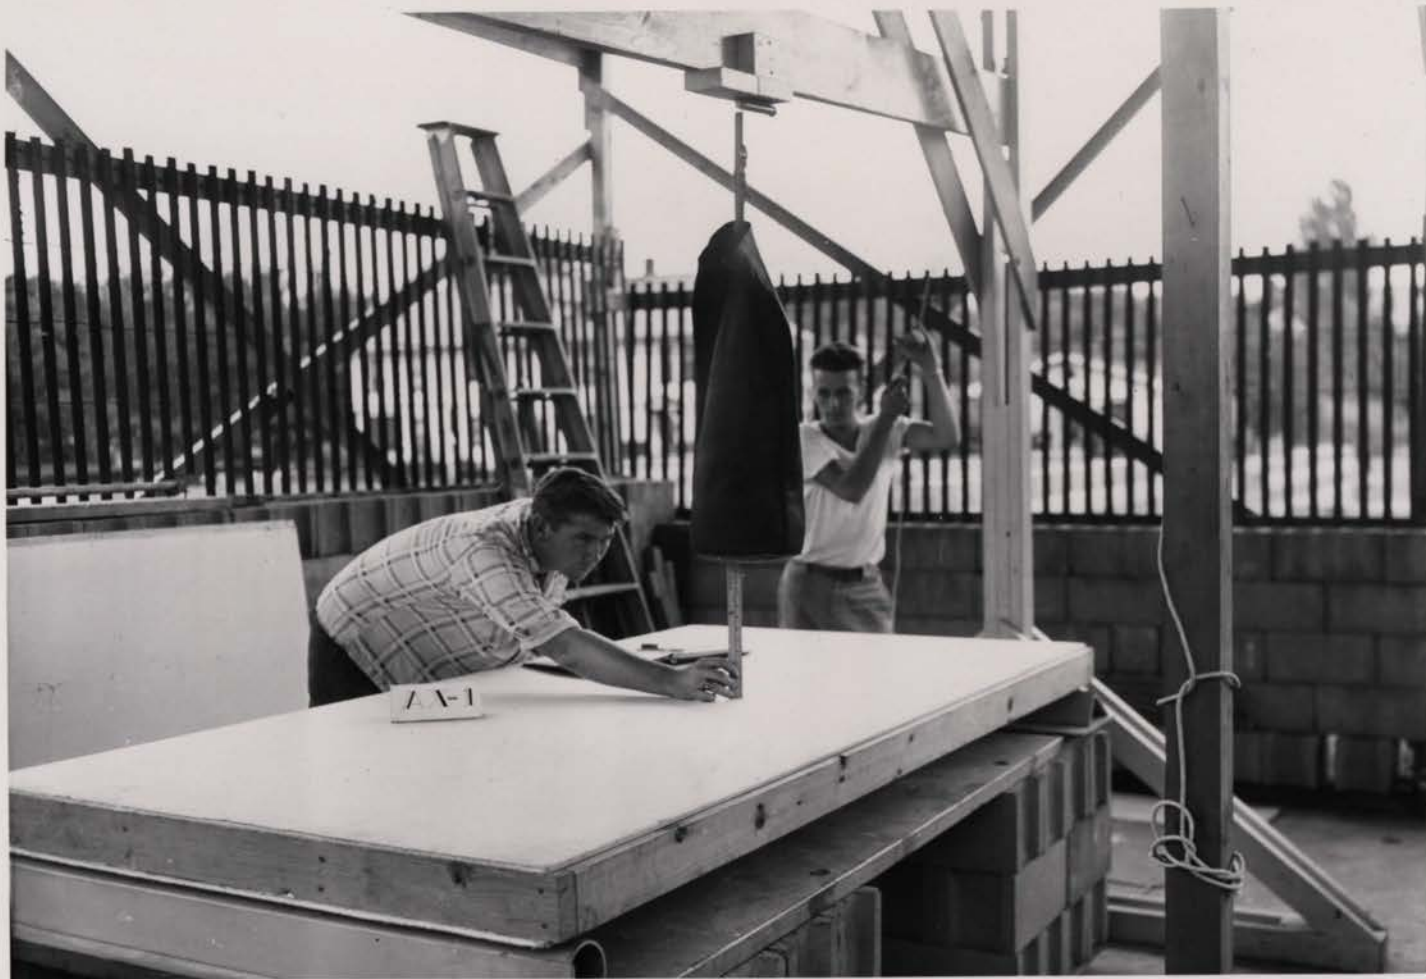
FIGURE 3-6

STUD WALL SPECIMEN - IMPACT LOAD TEST

- A - Stud wall specimen
- B - Knife edge supported
- C - Roller support
- D - Sand bag
- E - Height indicator

The method of supporting the specimen under the three different test loads requires some explanation. Under the concentrated load test the stud wall specimen were tested on a platform G, Figure 3-2 which supported the element as a whole but allowed deflection of the element cover. For the uniform and impact load tests the stud wall specimen were tested as simple beams with a 7' 6" span utilizing roller C and knife edge B supports, Figure 3-6.

1 - Loading: An impact load was applied to the specimen by dropping a sand bag weighing 60# D, Figure 3-6, at the weakest point of the element, not the element cover. The bag was constructed of leather in strict accordance with the specifications outlined in B.M.S. 2.

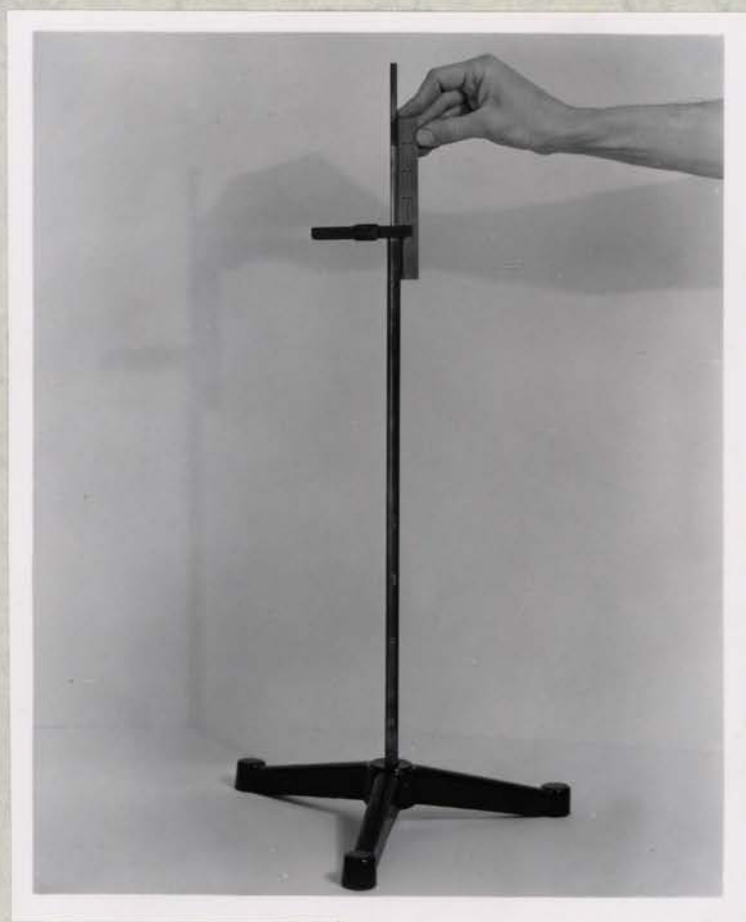
FIGURE 3-5
DEFLECTOMETER

- A - Three legged base
- B - Steel tube
- C - Scale
- D - Friction clamp
- E - Graduated steel rod

2 - Apparatus: To measure the deflection of the specimen under the uniform load, a deflectometer, Figure 3-5 was employed. The deflectometer consists of a metal tube B, screwed into a three legged stand A. A steel rod E is set inside of the tube B and held by the friction clamp D. The rod is placed in contact with the unloaded face of the specimen located at the weakest point of the element. As the specimen deflects under load, the rod is forced down into the metal tube.

3 - Results: By measuring to a fixed line on the rod E, Figure 3-5 before and after a load is applied the deflection may be recorded as the difference of the two readings of the deflectometer. A steel scale C calibrated in one sixty-fourth of an inch was used and readings were recorded to the nearest division.

2 - Apparatus: To measure the instantaneous deflection of the specimen, readings were made on the bottom surface of the panel at the axis of impact with the deflectometer, Figure 3-5, described under the uniform load test. The set was measured on the top surface at the axis of impact by the set gauge, Figure 3-7, also described previously under the uniform load test.

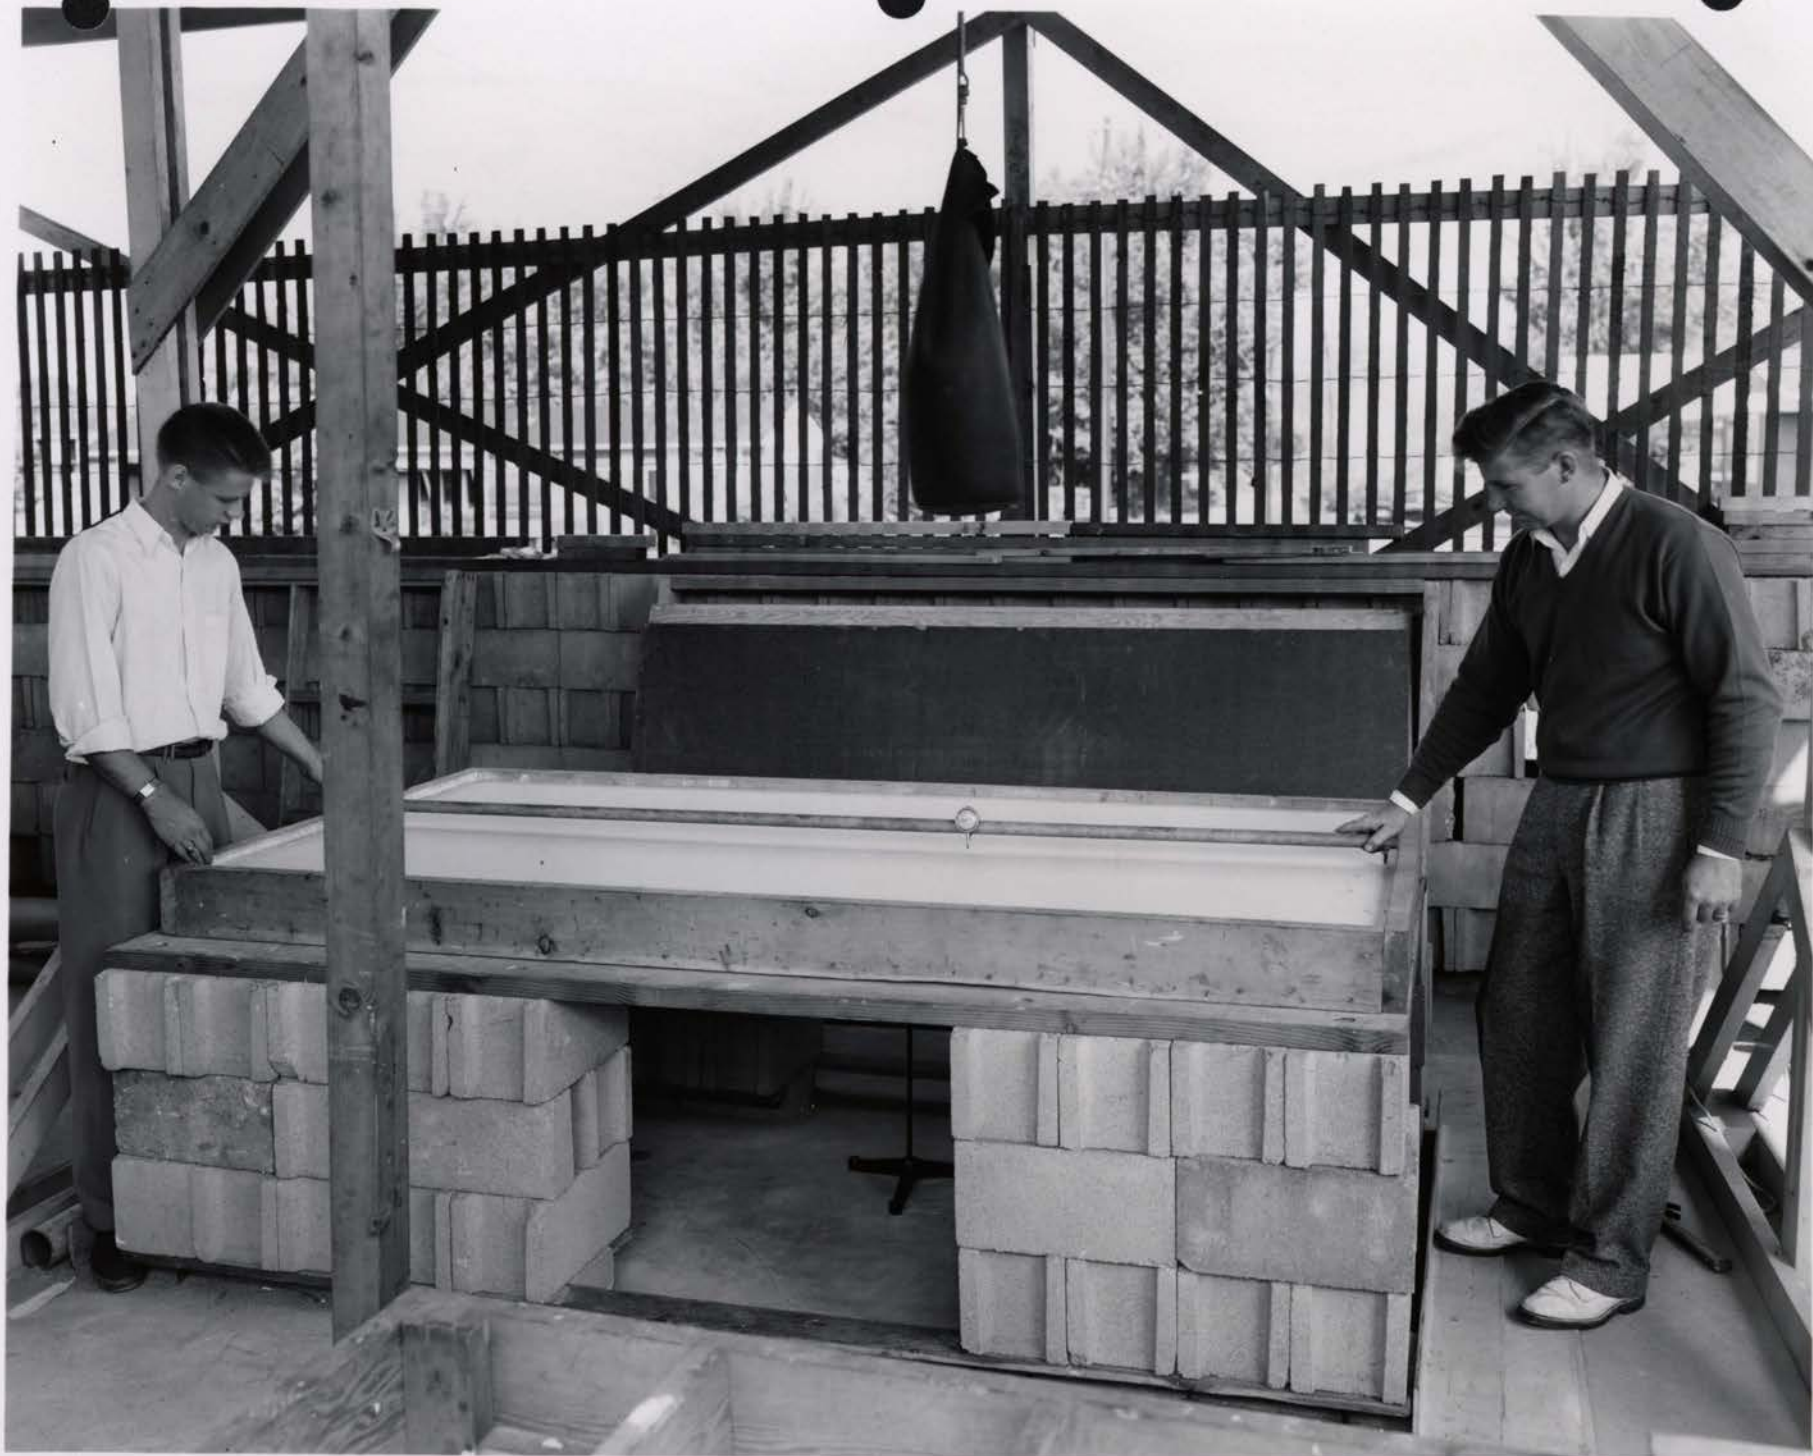
FIGURE 3-7

LAMINATED PANEL - IMPACT LOAD TEST

- A - Test frame
- B - Laminated specimen
- C - Three legged tubular frame
- D - Sand bag
- E - Deflectometer
- F - Dial micrometer

To measure the set, a set gauge Figure 3-7 was used. The gauge, consisting of a three legged tubular frame C and a dial micrometer F attached to the tube at the desired location, was placed on the unloaded face of the specimen.

Residual deflection could not be measured with the set gauge, Figure 3-7, until the final load had been applied and removed. Throughout the testing, the specimen were under constant surveillance in an effort to observe damage or failure. The results of the uniform load test have been recorded graphically and can be reviewed in the Appendix. Observations of damage and failure are also available in the Appendix.

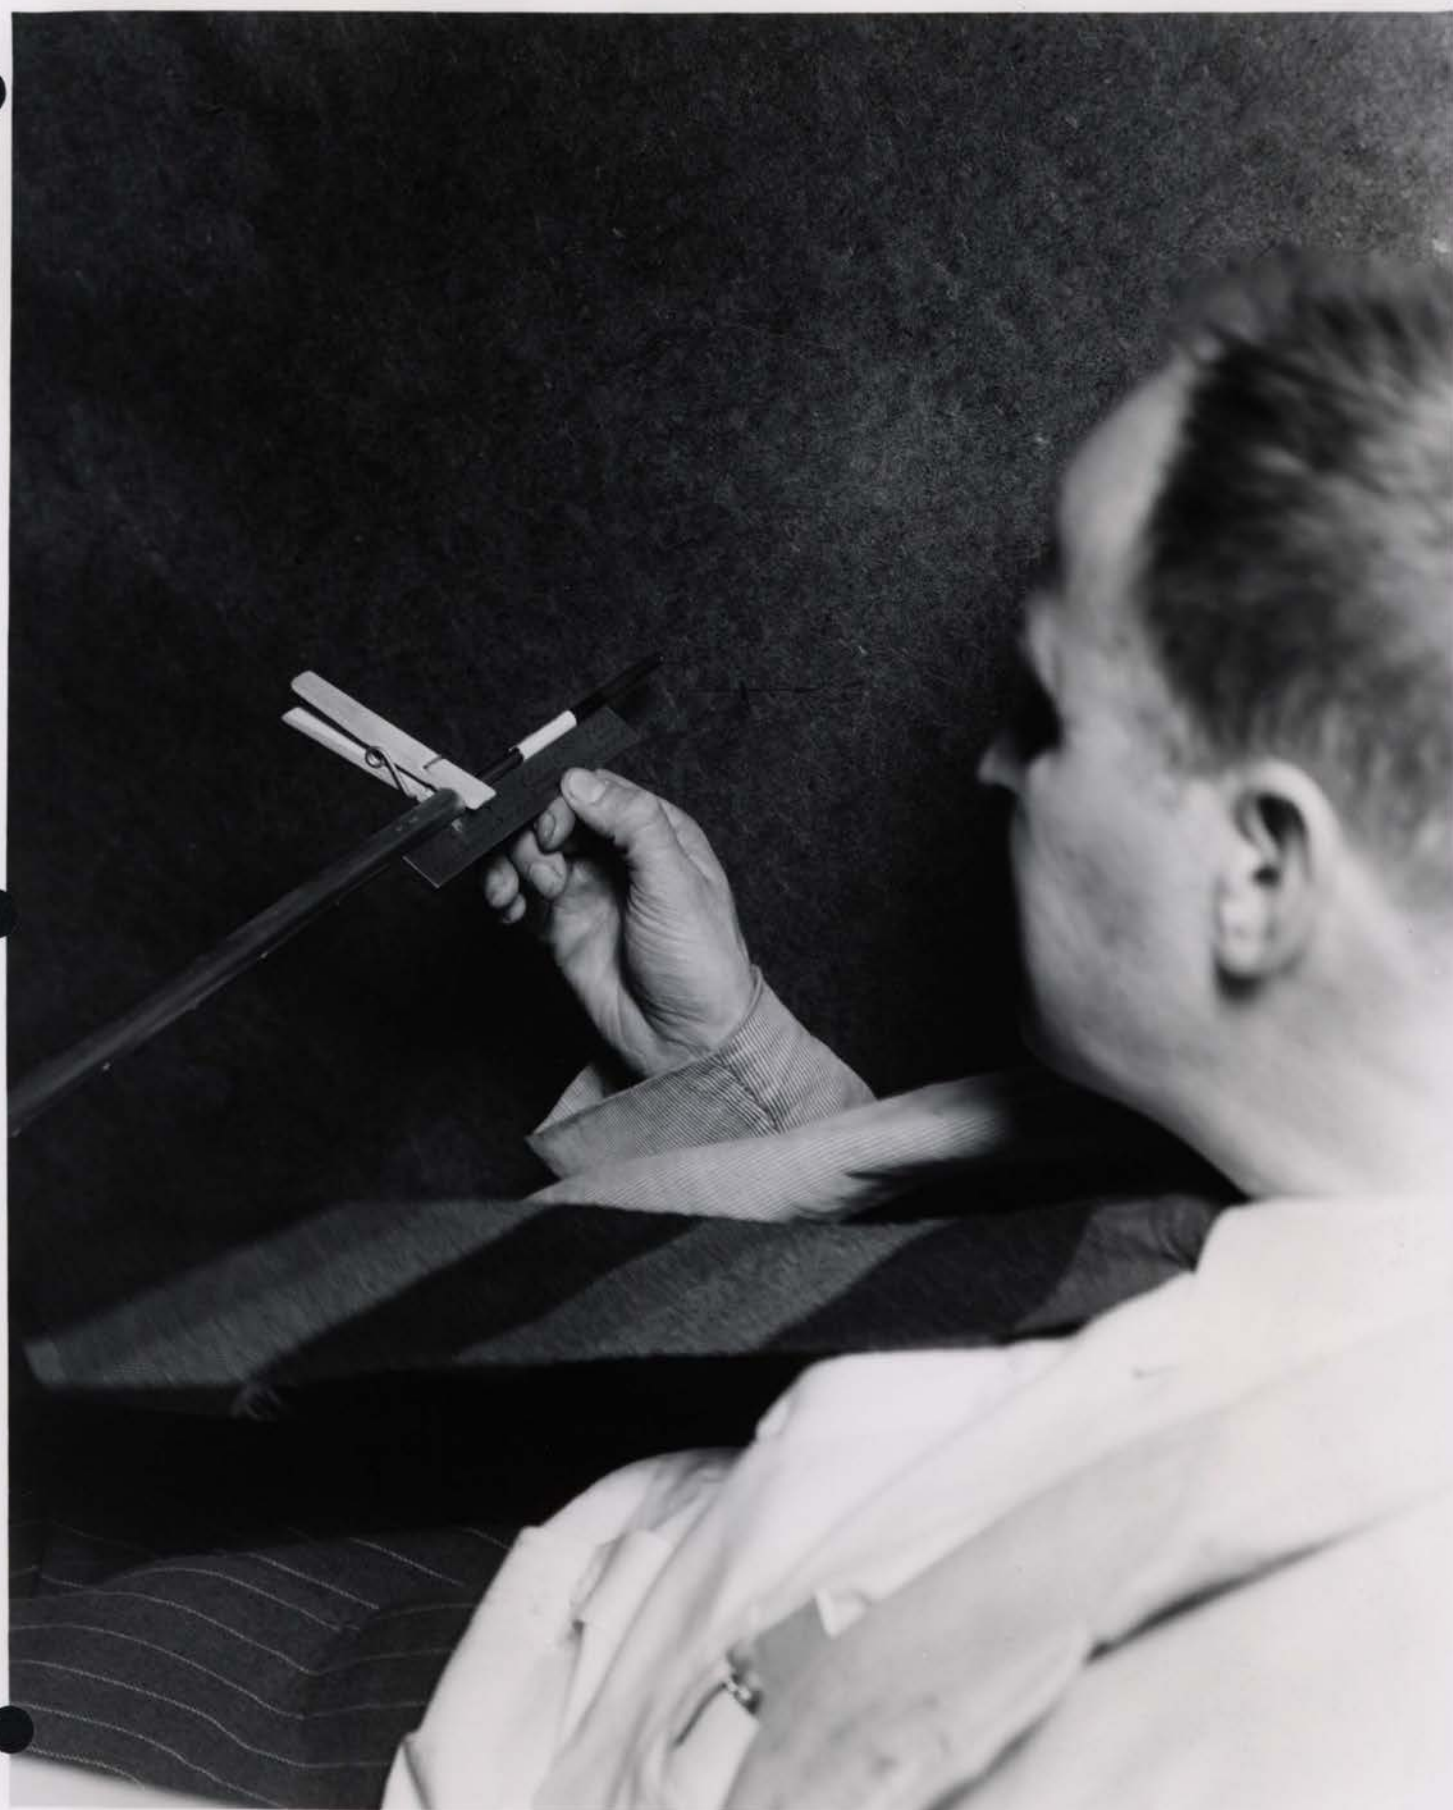
MEASURING DEFLECTION ON WORKING MODEL

- A - Hardboard side of laminated panel
- B - Steel scale
- C - Deflectometer

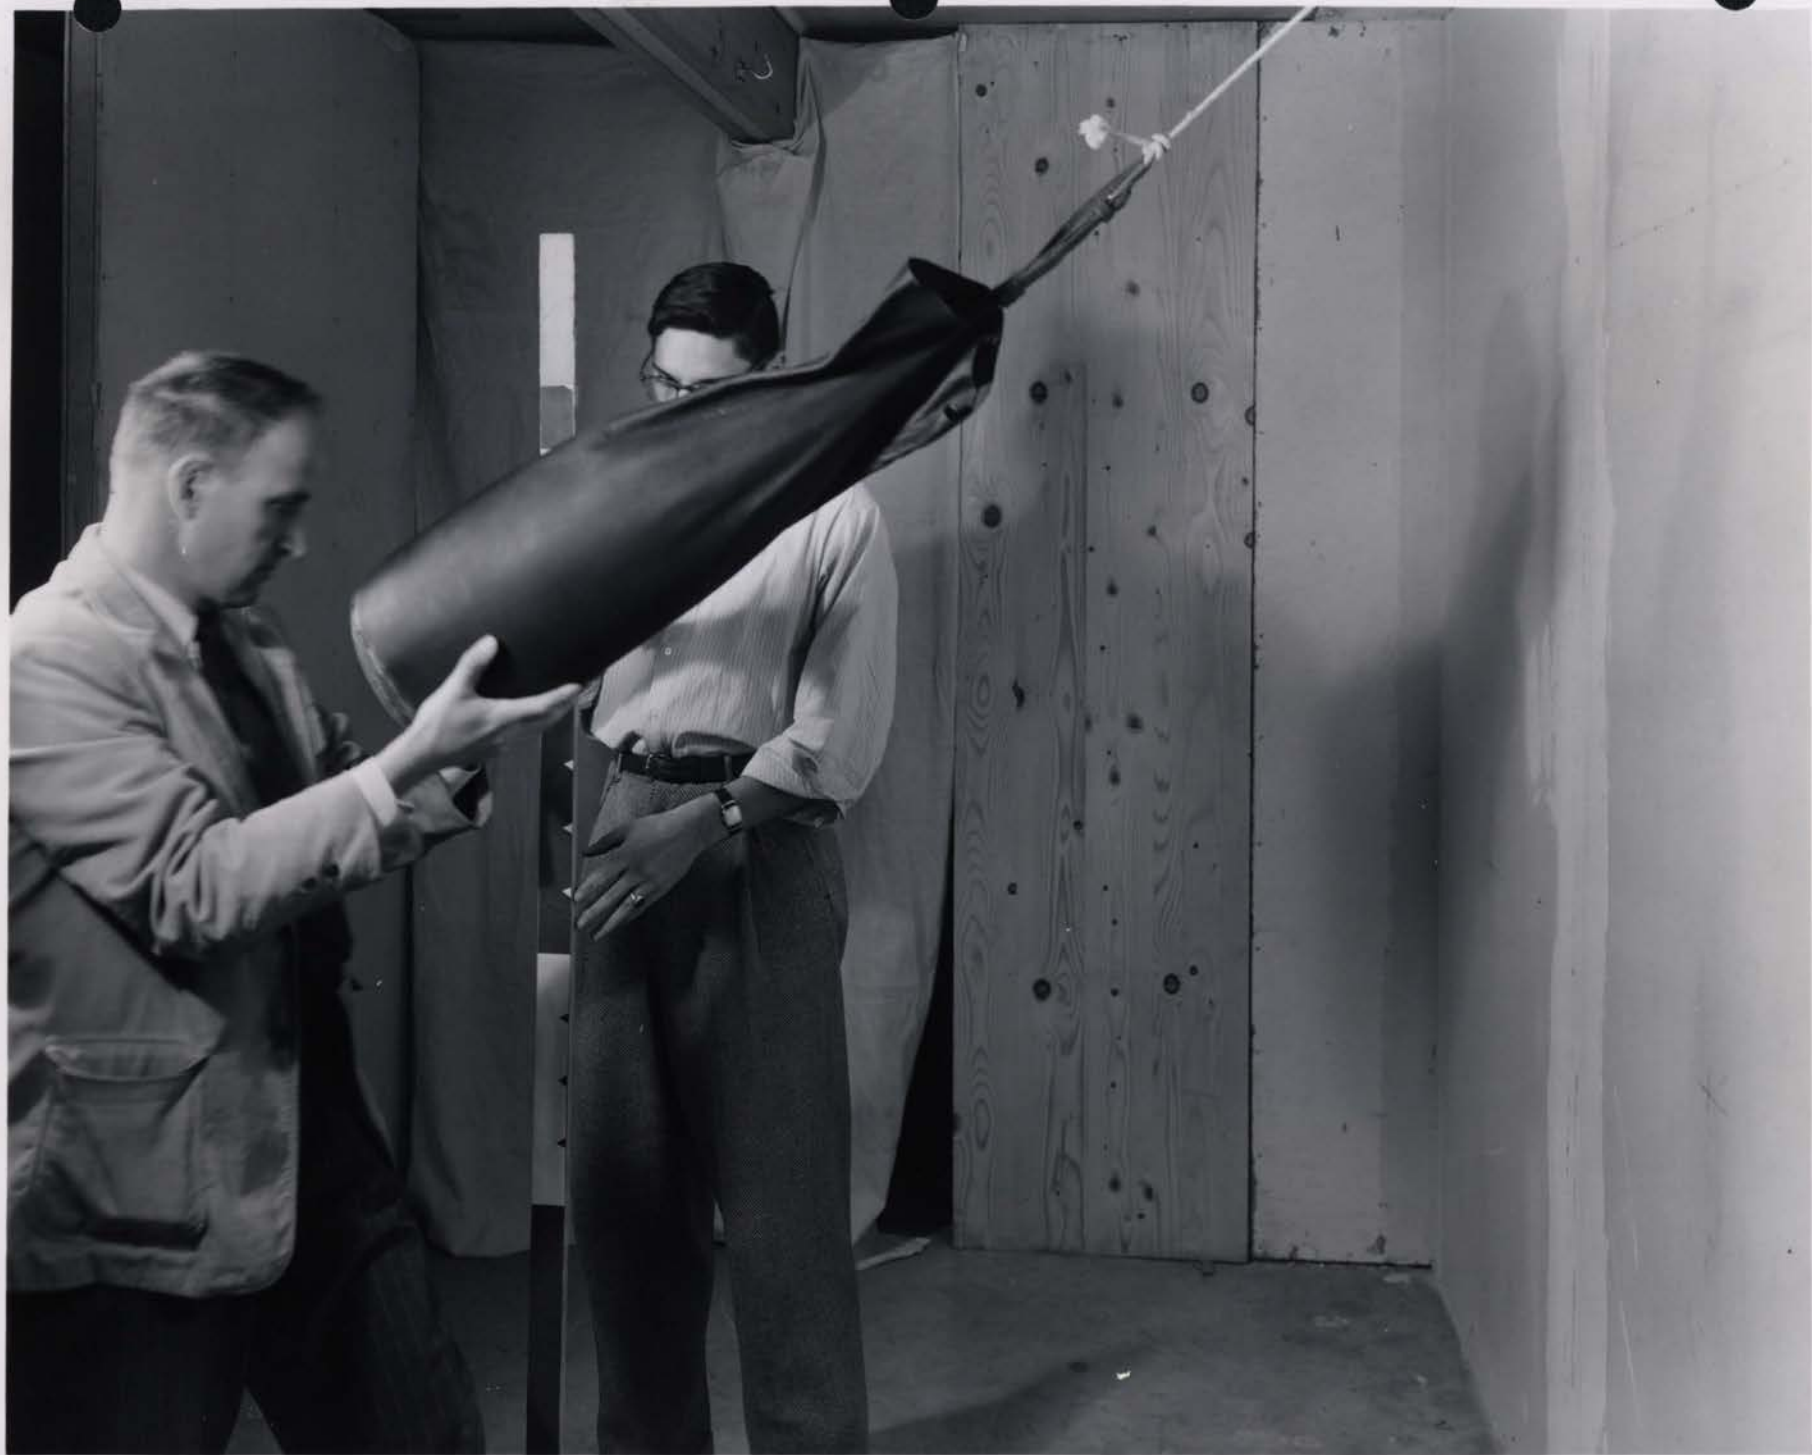
SWINGING SAND BAG TEST ON WORKING MODEL

- A - Back wall of compartment 2
- B - Height indicator
- C - Swinging sand bag

after each impact so as to determine the deflection and set. The tests were continued with successively higher drops until the panel failed or up to the limit of 36", Figure 3-9.

The 5' arc for the impact was smaller than is generally recommended; however, it is the maximum that was possible for the working model installed in a run with an 8' ceiling.
